Retention Basin

Best Management Practice (BMP) Maintenance Considerations

Retention Basin Inspection and Maintenance Checklist

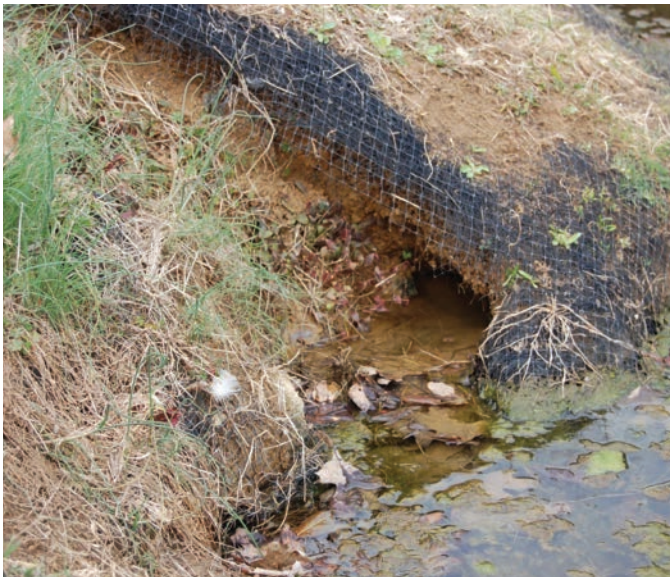
A muskrat has created a hole in the turf reinforcement mat and a tunnel into the bank, destabilizing the embankment.

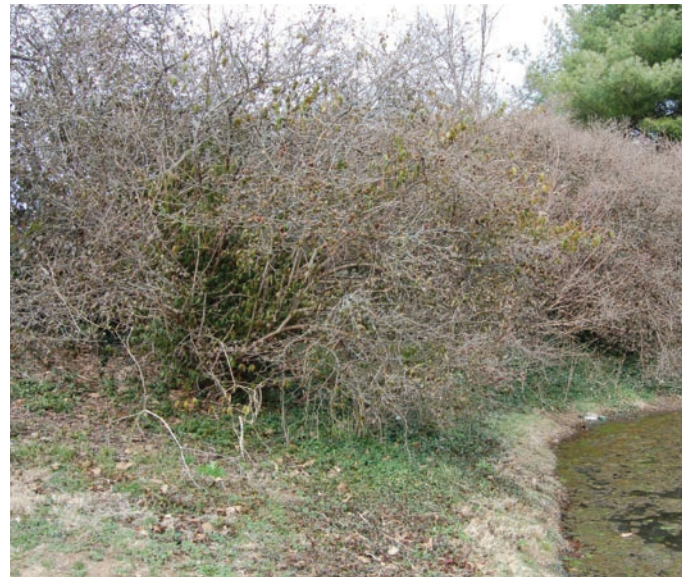
Japanese bush honeysuckle, an invasive plant species, is invading this embankment.

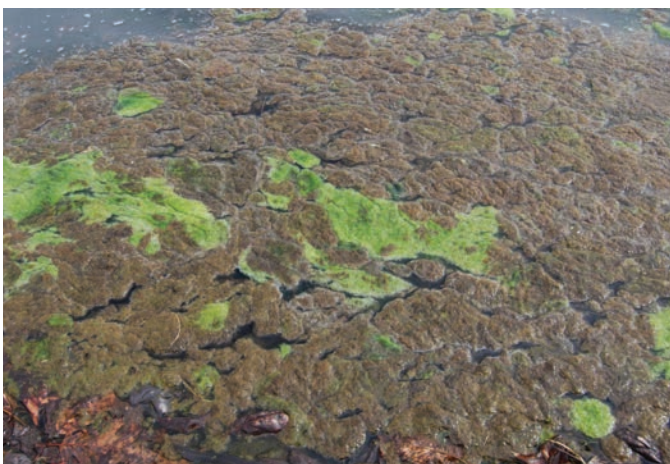
Algal growth is caused by excess nutrients.

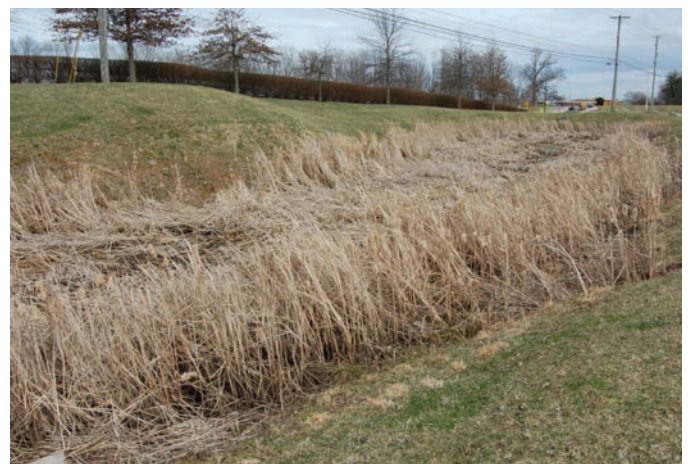
Cattail, an invasive plant species, is covering the entire surface area of this retention basin.

Native wetland plants biologically uptake pollutants and add aesthetic value. In some cases, vegetation harvesting and control of invasive aquatic plants (e.g., cattails) are necessary (when more than 50 percent of the surface area is covered) and should be implemented before winter die-off to prevent nutrient release into the water column.
